Chapter 4 – Appendix

TCON Troubleshooting

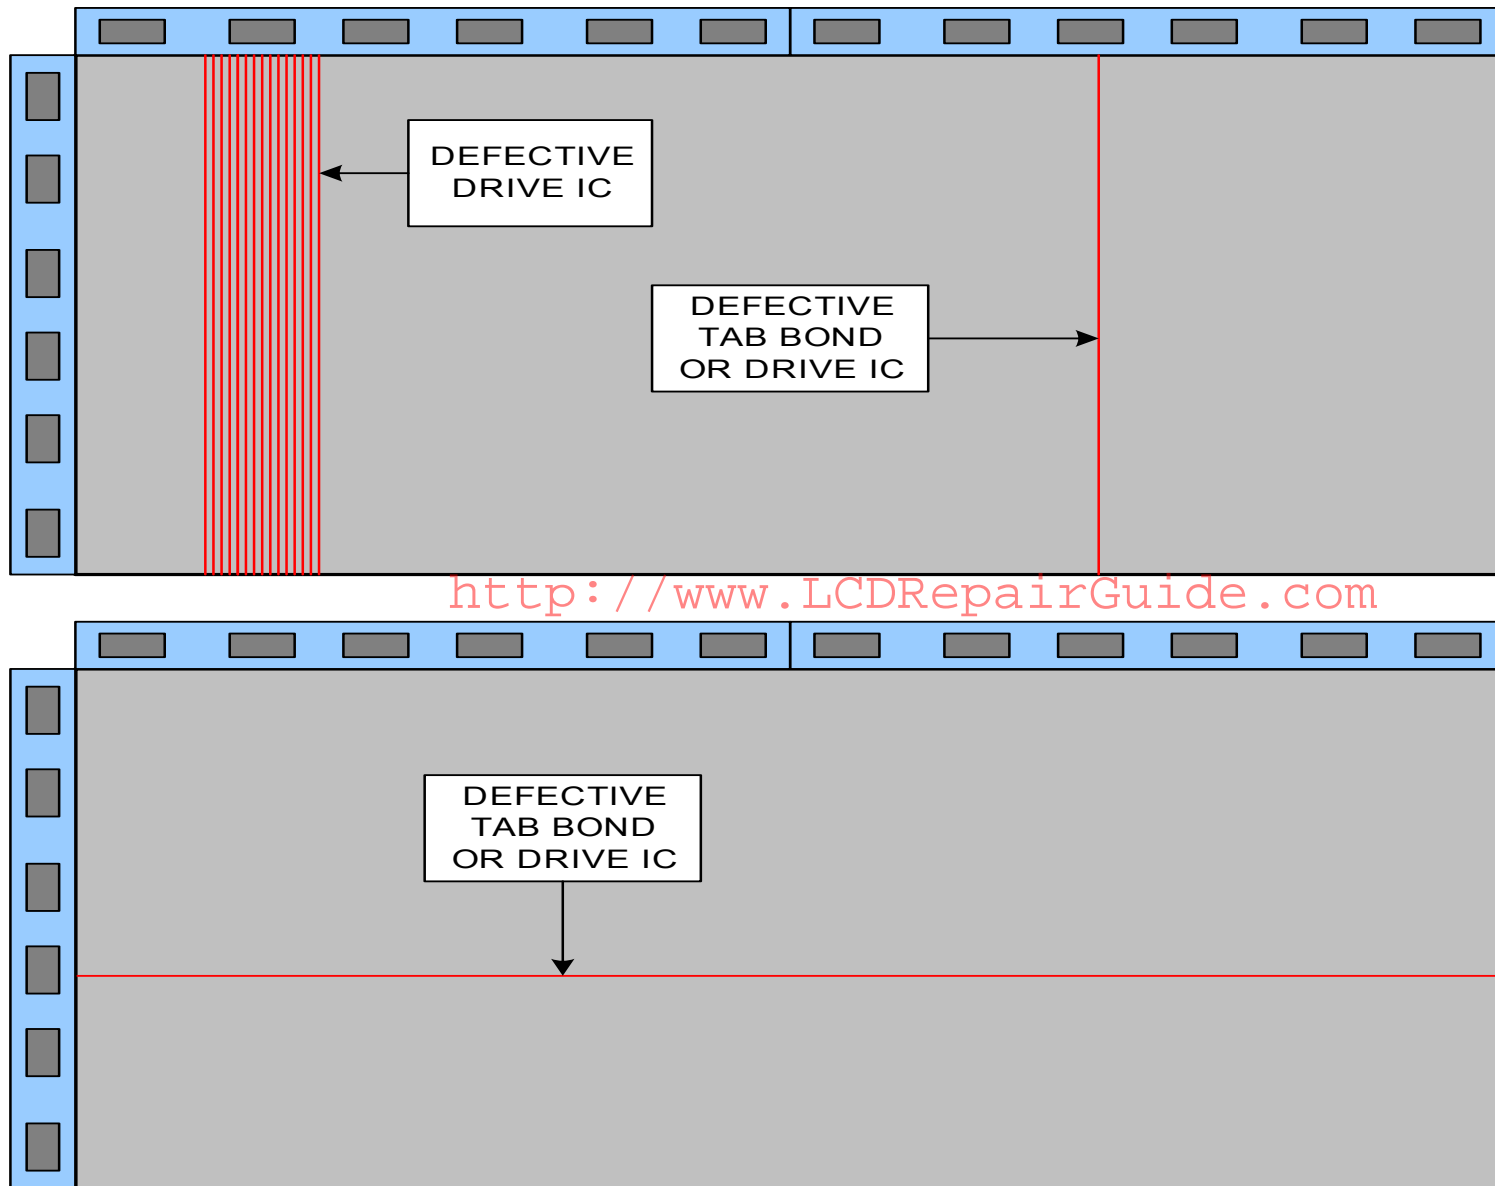
FIGURE 4-2
TYPICAL LCD PANEL FAILURES

LCD Panel Failures: Some LCD panel failures could possibly be mistaken for TCON issues. Other than damage to the LCD glass, most panel failures are isolated to a particular area of the screen. Since the TCON disperses the pixel data to groups of line and column drive IC's situated on the outer edges of the panel, it is unlikely that more than one of these IC's would fail at the same time. Multiple columns of stuck on or stuck off pixels are, therefore, more likely to be the fault of the TCON circuits. The same applies to a single row of lit or unlit pixels. The TCON simply cannot cut out a single line of information. Figure 4-2 illustrates some typical symptoms of failures that are caused by the LCD panel.

Failures involving the LCD panel are usually displayed with the following symptoms:

- Physical damage such as cracks in the panel, a single pixel or group of pixels that always on or off, or random sections of the panel which are completely dark.

- Source driver failure. This symptom appears as a single vertical band around 1 to 2 inches (depending on the panel size) and can be black, white, or any other color. It can also contain video information with distortion. A single vertical line that is dark or colored. This may be due to a tab bonding failure from the IC to the panel but either cause requires the replacement of the panel.

- Gate driver failure. These IC's operate in a "bucket brigade" fashion. As mentioned earlier, the gates drivers scan each horizontal line starting at the top. If any one of the gate drivers fails, all of the subsequent drivers below it will fail to operate properly. This symptom is usually indicated by normal video on the upper portion of the screen followed by distorted video from the point of the failed IC and downward.

- Any horizontal lines. The gate drivers are activated by a single source of timing information so any single horizontal line or groups or random horizontal lines are caused by an output failure from a gate driver or a loss of the tab bond to the panel.

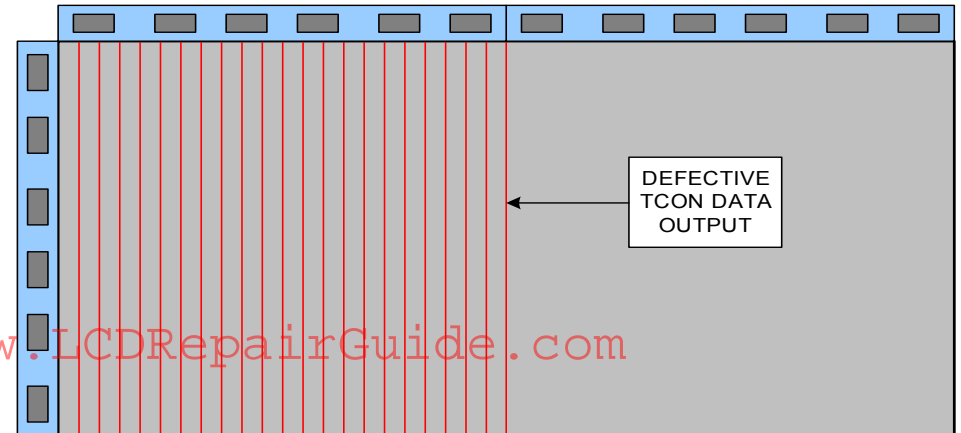
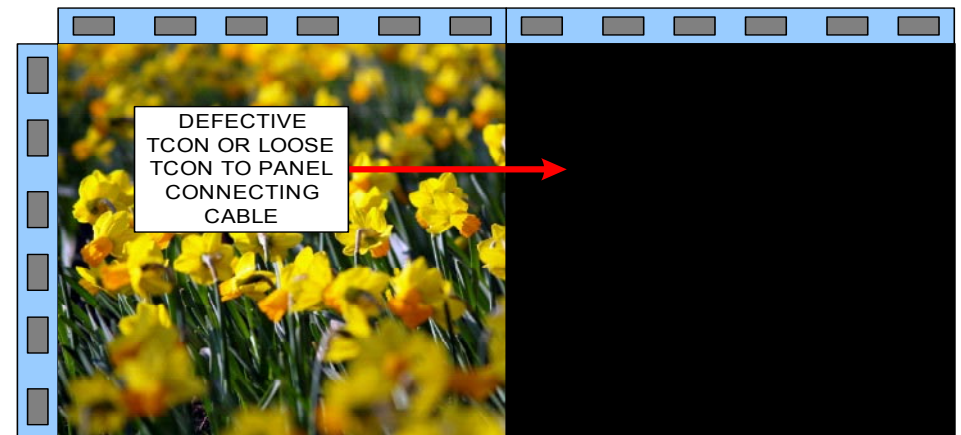
FIGURE 4-3
LCD TIMING CONTROL FAILURES

Figure 4-3 illustrates 2 examples of a loss of control data to the drive IC's. In the first example, an entire group of column drivers has lost the data stream for red. The second example involves the complete loss of drive data for all RGB information to the right side of the screen. This is sometimes caused by the flat cable connecting the TCON to the LCD panel coming loose. The area of missing video can be dark or completely white depending on the panel design.

Service Tip: Select an inactive input (or one that is known to be a 4:3 SD source) and toggle between the "normal" and "zoom" modes. If the lines follow the zoom changes, the problem is located on the video process board. If they stay in the same place, they are originating in the TCON or LCD panel.

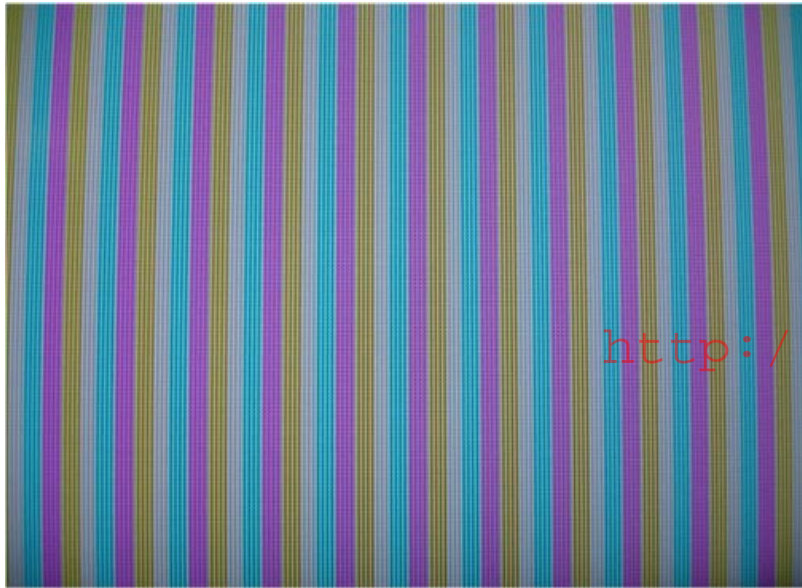
REPETATIVE STAIONARY LINES

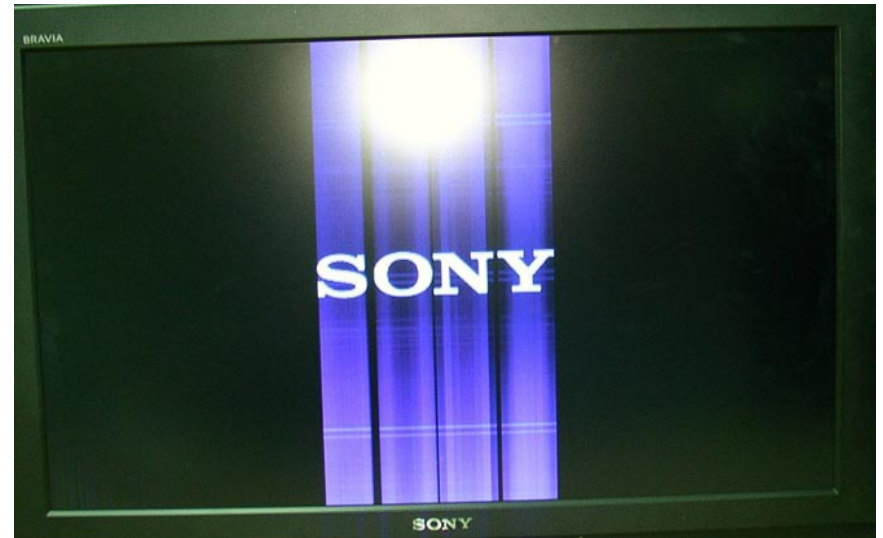
MULTIPLE SOURCE DRIVE IC FAILURE

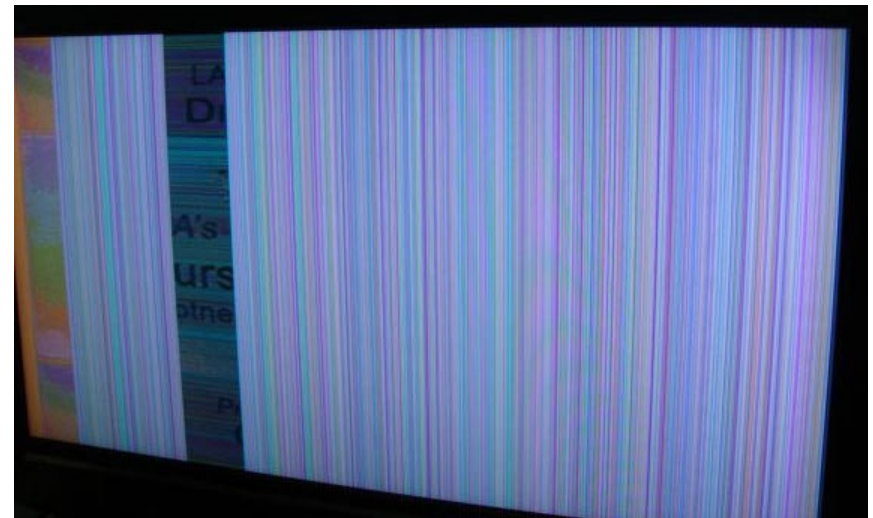
MULTI-COLORED LINES. NOTE THE PRESENCE OF SOME ACTIVE VIDEO INDICATING THE VIDEO PROCESSOR IS NOT THE CAUSE

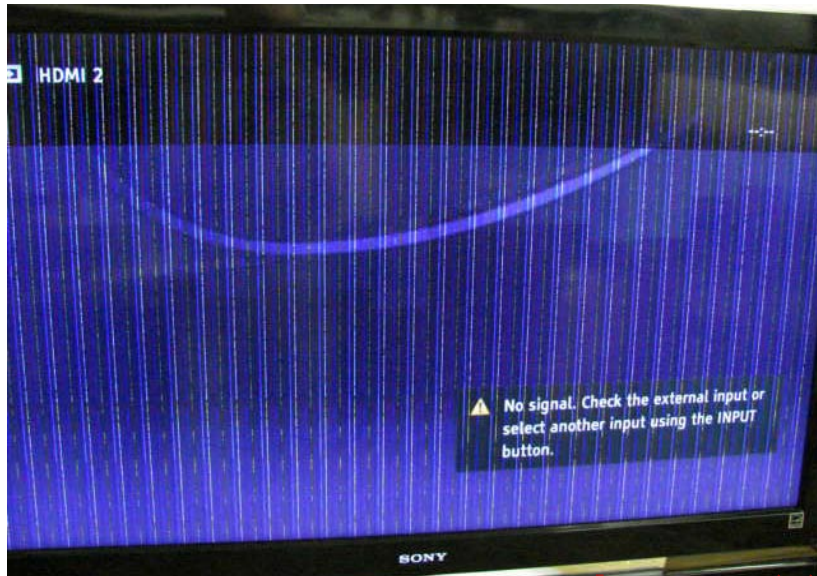
MULTIPLE EVENLY SPACED LINES NOT AFFECTED BY PICTURE ZOOMING

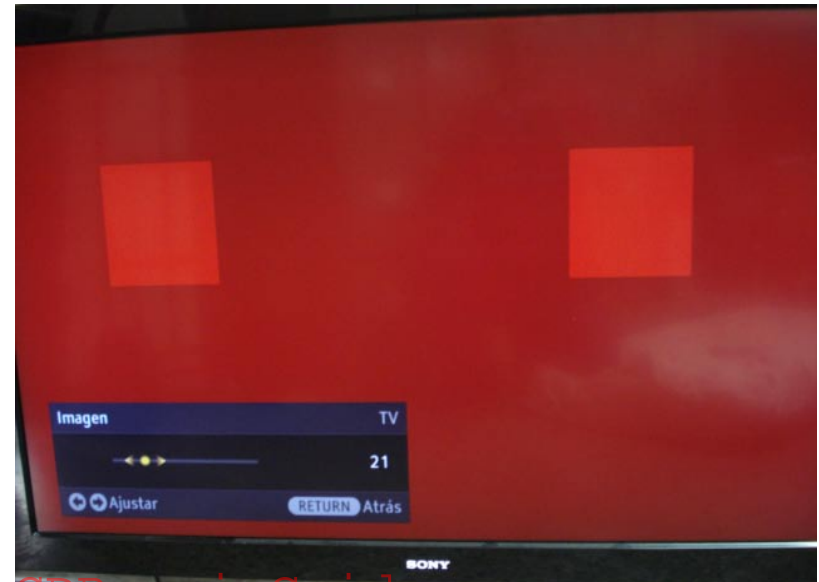
SYMMETRICAL RED BOXES

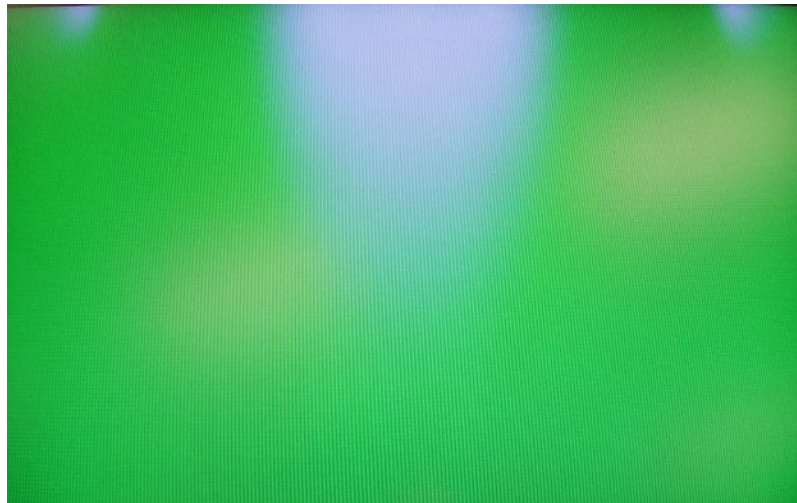
LOADED SOURCE DRIVE DATA LINE

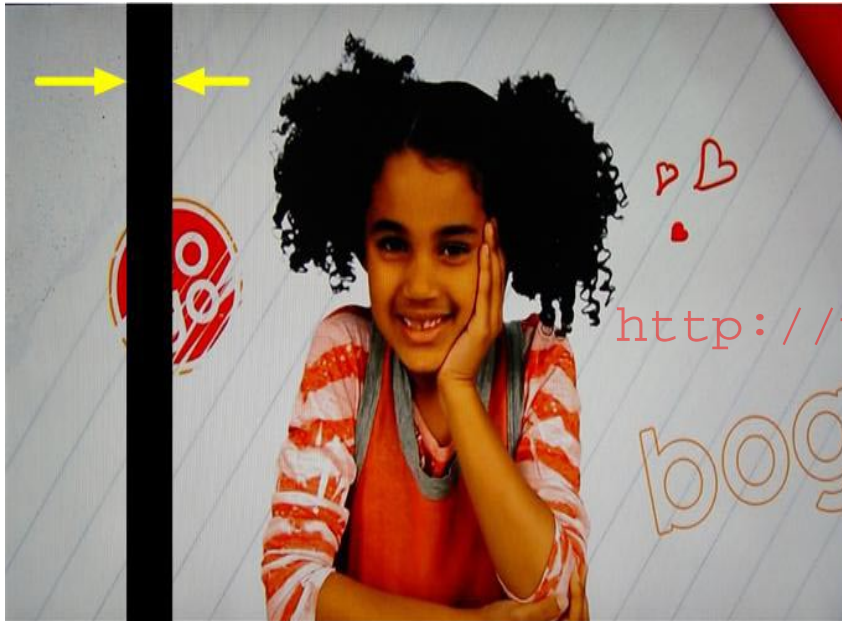
SOURCE DRIVE IC FAILURE

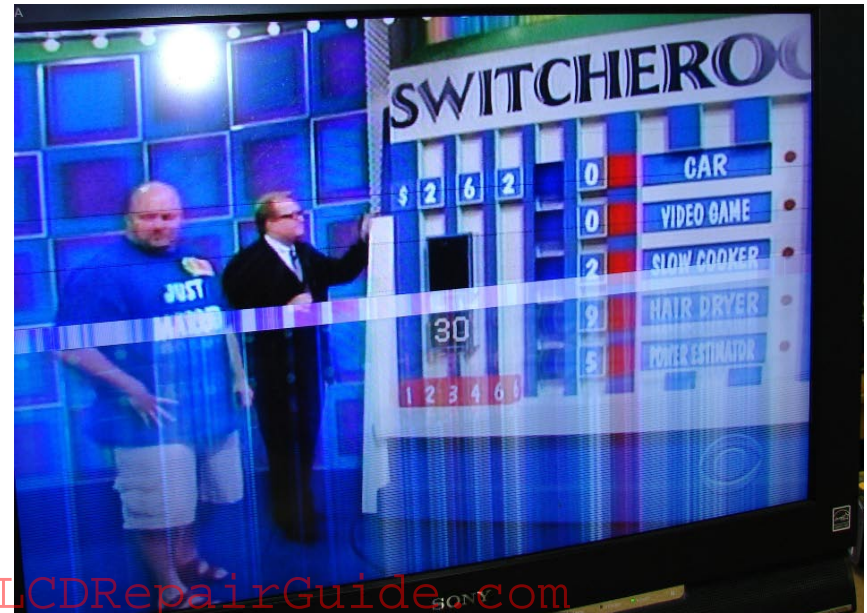
GATE DRIVER FAILURE

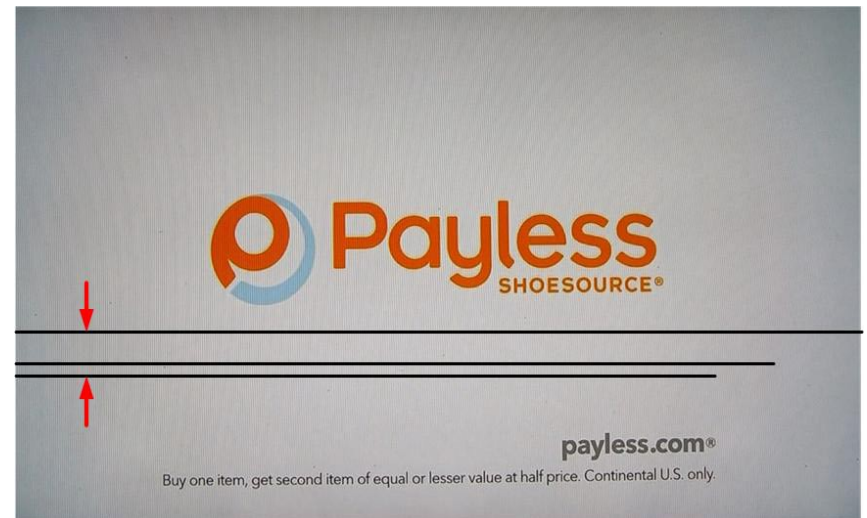
GATE TAB BOND FAILURE

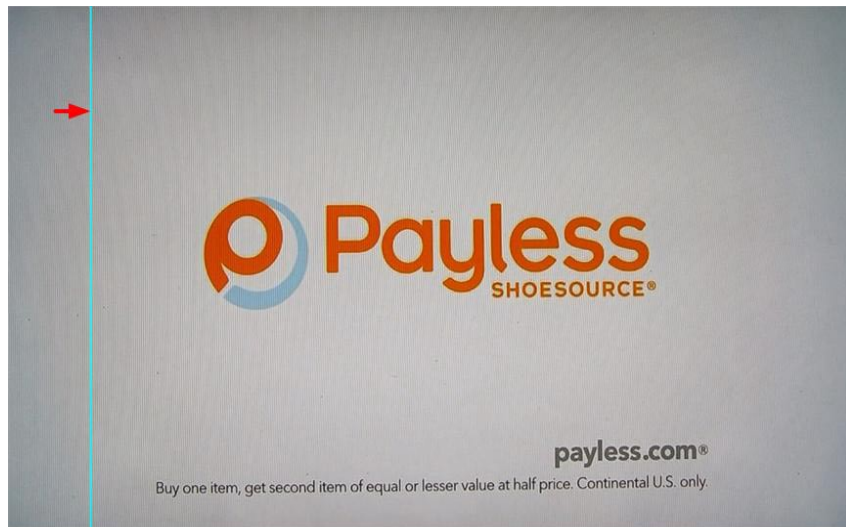
SOURCE TAB BOND FAILURE

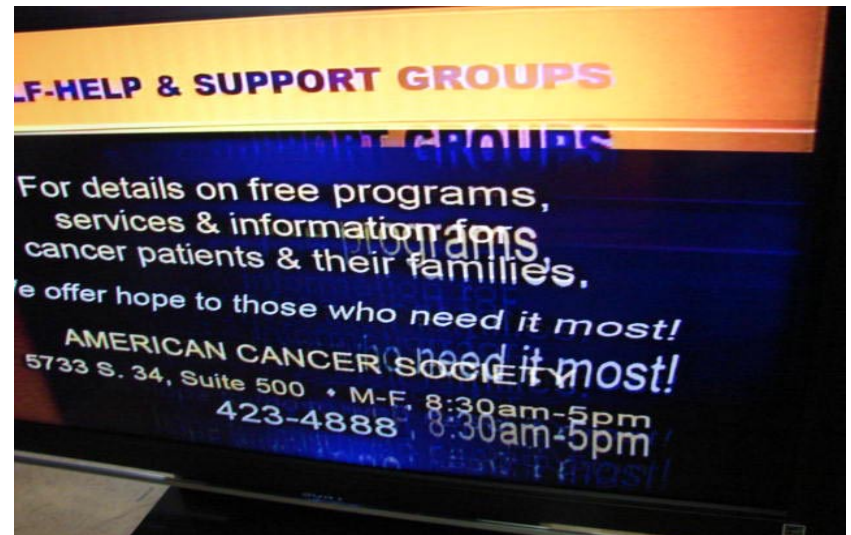
GATE TAB BOND FAILURE

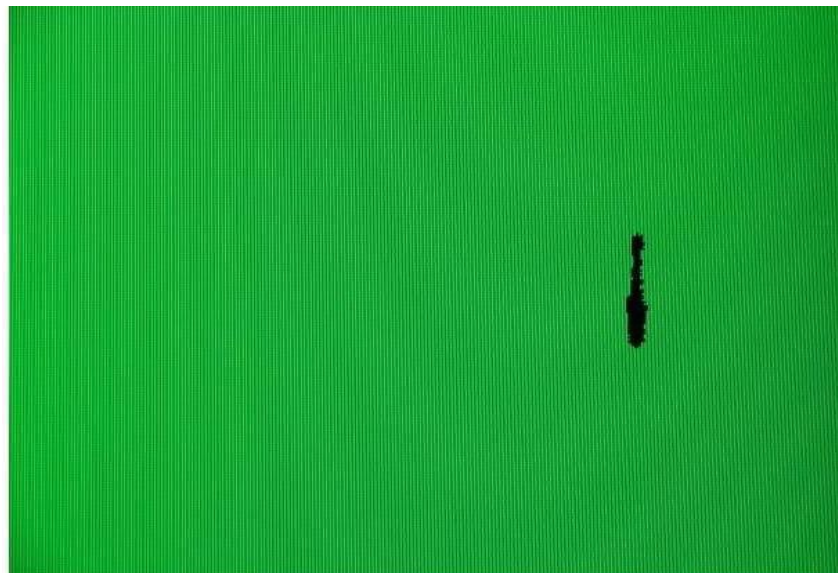
MULTIPLE PIXEL FAILURE

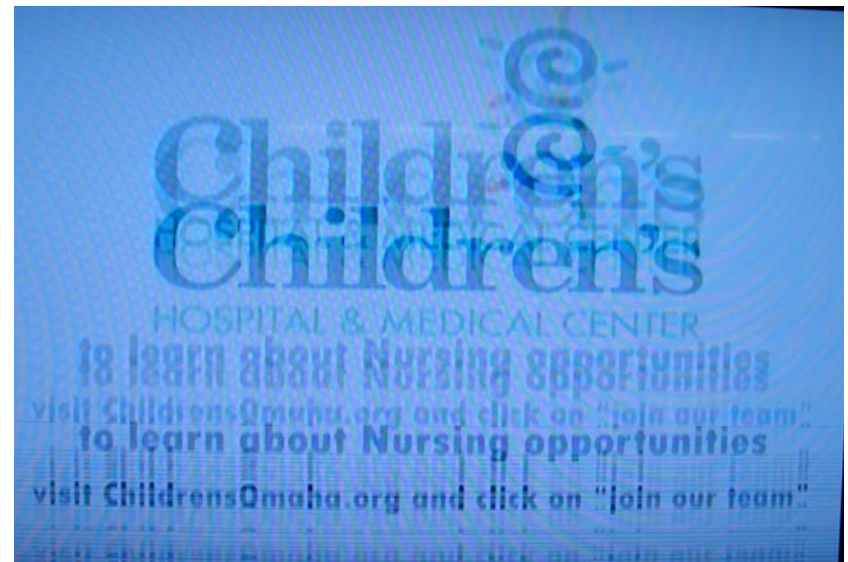
GATE TAB BOND FAILURE
